Local buckling of pier box vertical plate owing to the lack of stiffeners - collapsed cantilever arm falling on the pier

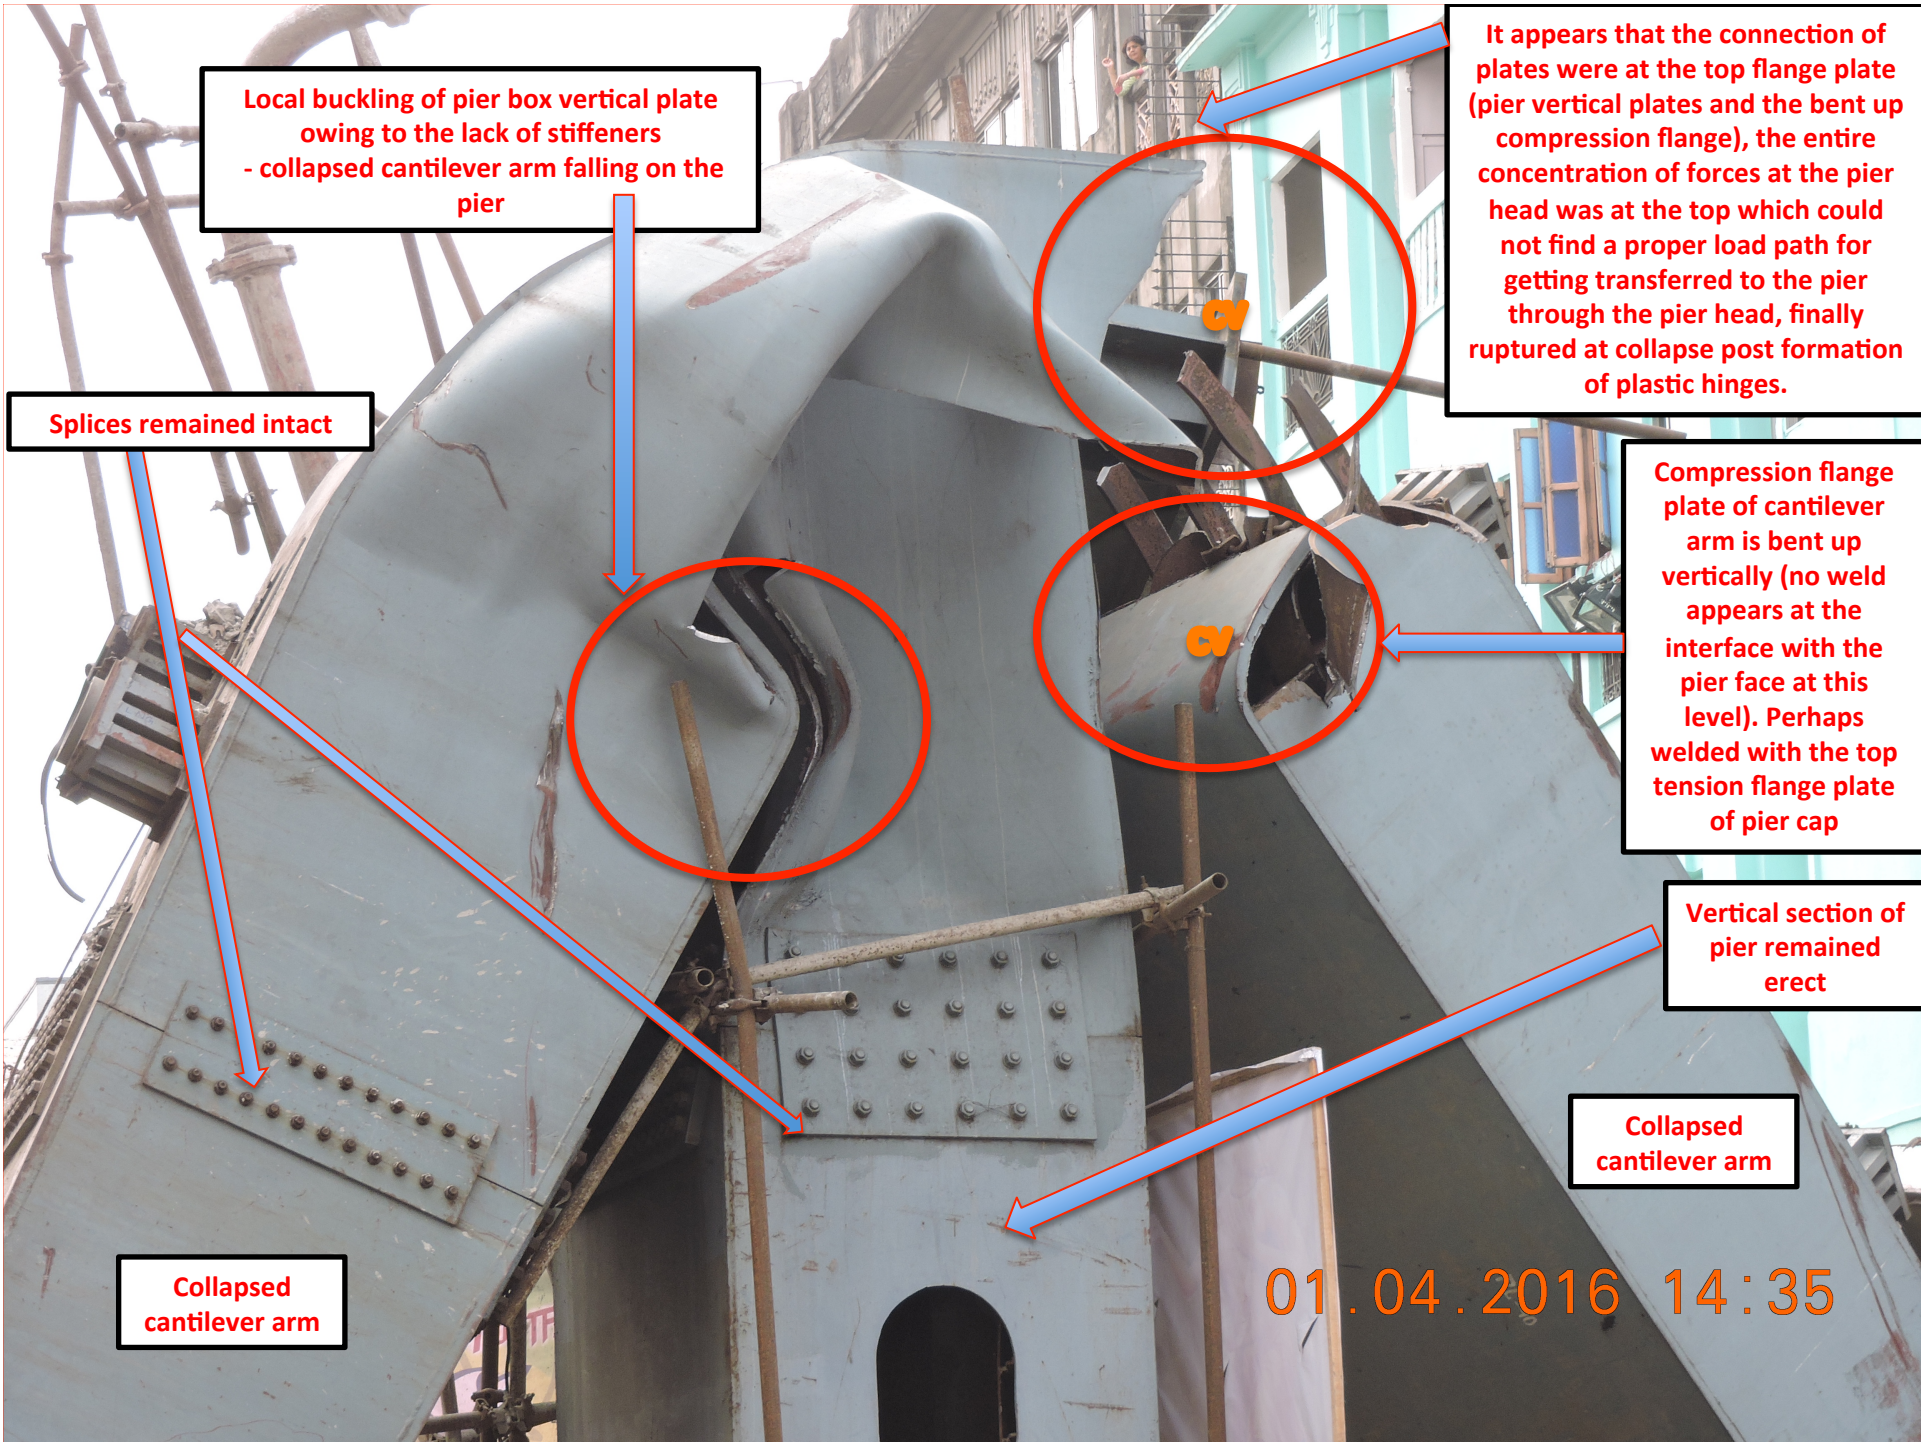
It appears that the connection of plates were at the top flange plate (pier vertical plates and the bent up compression flange), the entire concentration of forces at the pier head was at the top which could not find a proper load path for getting transferred to the pier through the pier head, finally ruptured at collapse post formation of plastic hinges.

Splices remained intact

Compression flange plate of cantilever arm is bent up vertically (no weld appears at the interface with the pier face at this level). Perhaps welded with the top tension flange plate of pier cap

Vertical section of pier remained erect

Collapsed cantilever arm
